Triggered Surface Slips in Southern California Associated with the 2010 El Mayor-Cucapah, Baja California, Mexico, Earthquake

Open-File Report 2010-1333

Jointly published as California Geological Survey Special Report 221

By Michael J. Rymer, Jerome A. Treiman, Katherine J. Kendrick, James J. Lienkaemper, Ray J. Weldon, Roger Bilham, Meng Wei, Eric J. Fielding, Janis L. Hernandez, Brian P. E. Olson, Pamela J. Irvine, Nichole Knepprath, Robert R. Sickler, Xiaopeng Tong, and Martin E. Siem

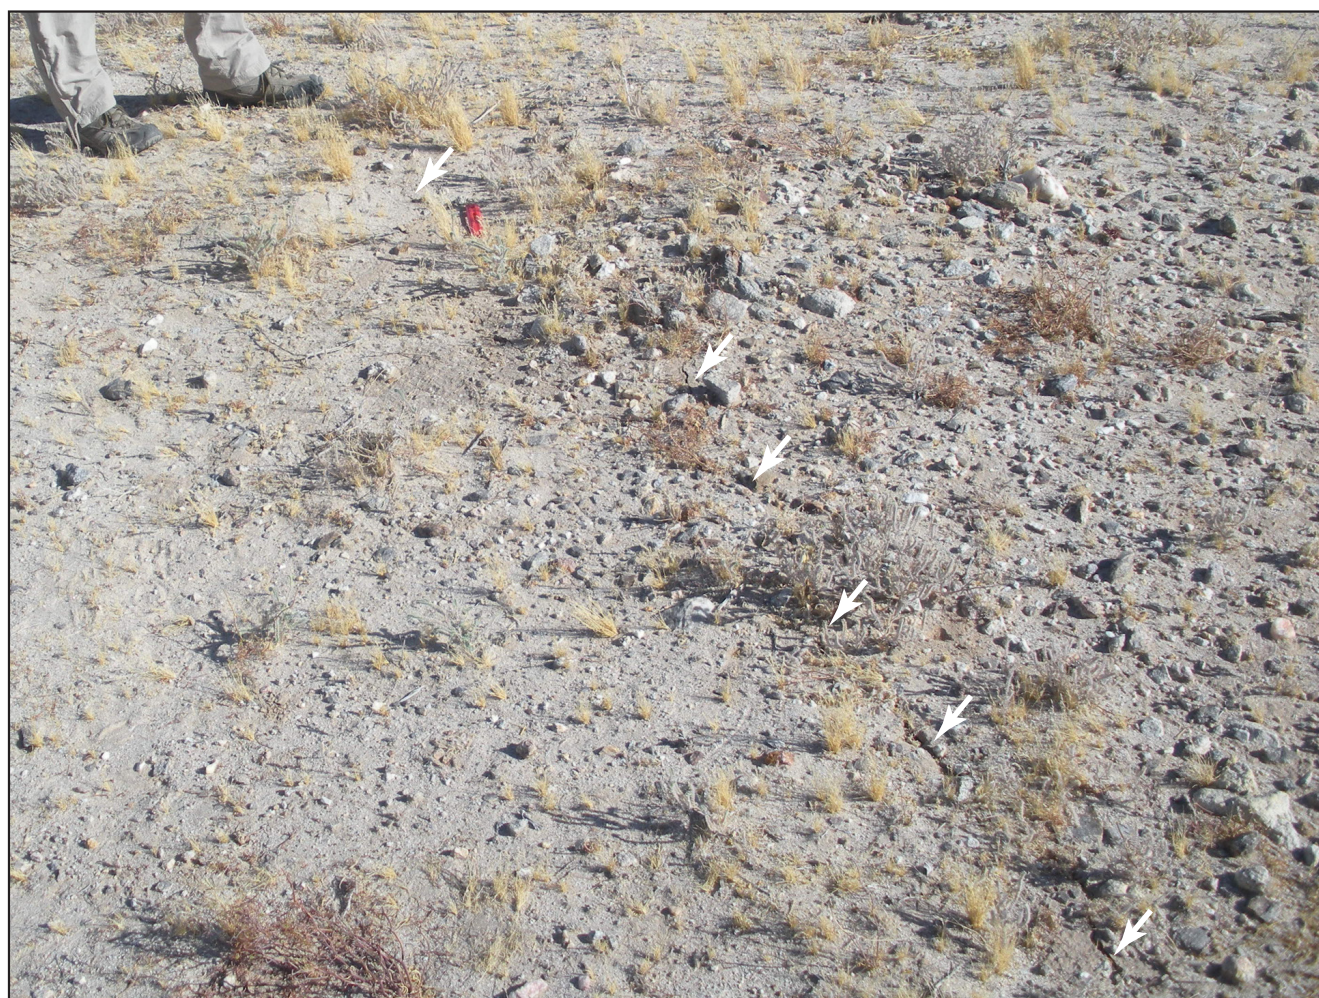
Figure 32. Photograph of fractures along an unnamed fault shown in figure 31. This isolated zone of minor fractures lies 2 kilometers southwest of the Laguna Salada Fault.

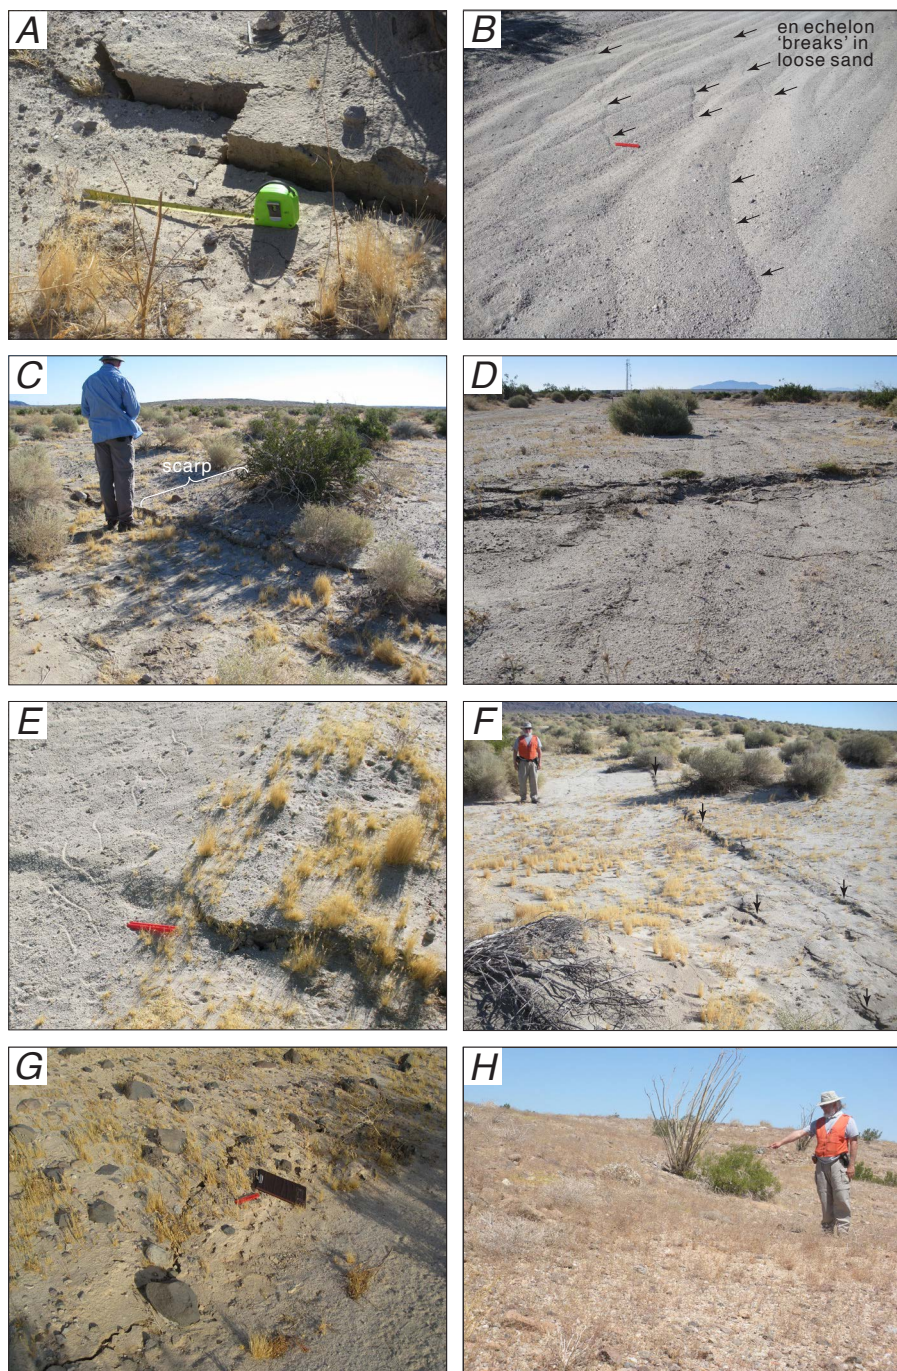
Figure 34. Photographs of fractures and fault scarps along faults shown in figure 33. *A*, Vertical surface fractures along Ocotillo Fault. Faulting here is associated with the nearby M_w 5.7 aftershock of June 14, 2010. Photograph taken June 16, 2010. *B*, Left-stepping, right-oblique surface fractures along Ocotillo Fault in loose sand. Photograph shows en echelon 'breaks' (black arrows) in loose sand, suggestive of slight right-lateral component of slip; red ruler for scale. Photograph taken June 16, 2010. *C*, Fractures along Ocotillo Fault at base of preexisting west-facing scarp. View to northeast. Photograph taken June 16, 2010, by J.A. Treiman. *D*, Fractures along Ocotillo Fault in recent wash deposits; view to the southeast. Photograph taken June 16, 2010, by J.A. Treiman. *E*, Right-oblique fractures along Ocotillo Fault. Photograph includes brittle fault movement (on right) and diffuse fault slip in loose sand (on left). Loose sand section in this view includes fresh track from a sidewinder rattlesnake (to the left of red scale). Photograph taken June 16, 2010. *F*, Fractures with vertical slip along Ocotillo Fault in sandy soil; view to the north. Subtle fault scarp on east (right) side of fault. Photograph shows local structural complexity in rupture (in foreground). Photograph taken June 16, 2010. *G*, Right-lateral fractures along unnamed fault south of I-8. Black notebook and red ruler for scale. Photograph taken August 2, 2010, by J.A. Treiman. *H*, Photograph of scarp, about 1.5–2 m high, without fresh surface fractures; view to the northwest. Photograph taken June 16, 2010.

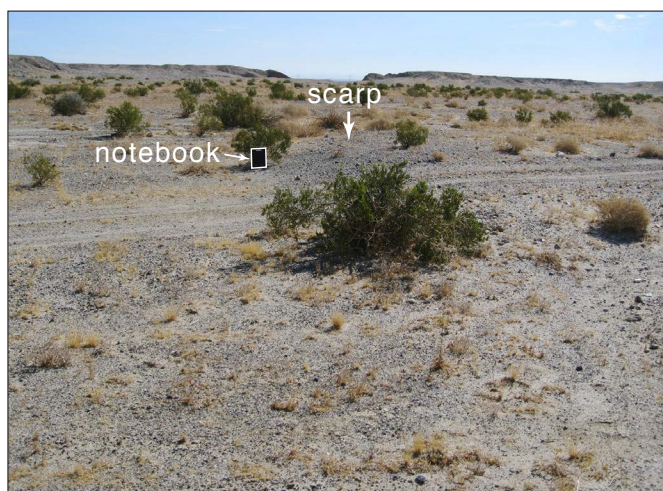
Figure 36. Photograph of fault scarp along fault farther northeast of surface slip in 2010 (see fig. 35 for location). Small white arrow points to black notebook (with white outline) for scale. Photograph taken August 3, 2010, by J.A. Treiman.
